Test Report

Item No. 1007833-B
0519523-S

SALT SPRAY TEST REPORT

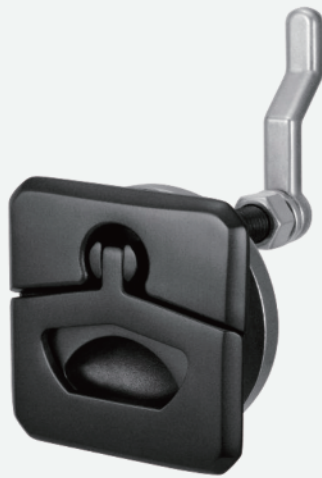
1007833-B

Test Result Summary	
Test Request	UV Exposure and Condensation Test
Testing Standards	ANSI BHMA A156.36-2016
	Products are under 60°C UV test for 8 hours and 50°C condensation test for 4 hours. Total of 144 hours for the cycle test.
Result	There is no break, crack, and discoloration or fading shown on samples.
